**TRANSPORTATION SCIENCES CENTER
ACCIDENT RESEARCH GROUP**

**CALSPAN ON-SITE AIR BAG DEPLOYMENT INVESTIGATION
CALSPAN CASE NO. 95-21
VEHICLE: 1995 DODGE CARAVAN
LOCATION: MARYLAND
CRASH DATE: [REDACTED] 1995**

This on-site investigation focused on a child fatality that resulted from the deployment of the passenger side air bag in a 1995 Dodge Caravan. The 7 year old female child occupant was the right front passenger in the Caravan that was occupied by the 43 year old male driver and two additional child occupants seated in the second seat of the seven passenger vehicle configuration. On an approach to a four-leg intersection, the driver was momentarily distracted and failed to detect a red signal phase. He braked, however, the full frontal area of the Caravan impacted the left side area of a 1992 Chevrolet Lumina APV which resulted in deployment of the Dodge's supplemental driver and passenger side air bags. The right front child occupant was out of position in a forward direction as a result of the pre-crash braking force and within a close proximity to the passenger side air bag module assembly. The deploying air bag contacted the underside of her chin, face, anterior neck, an

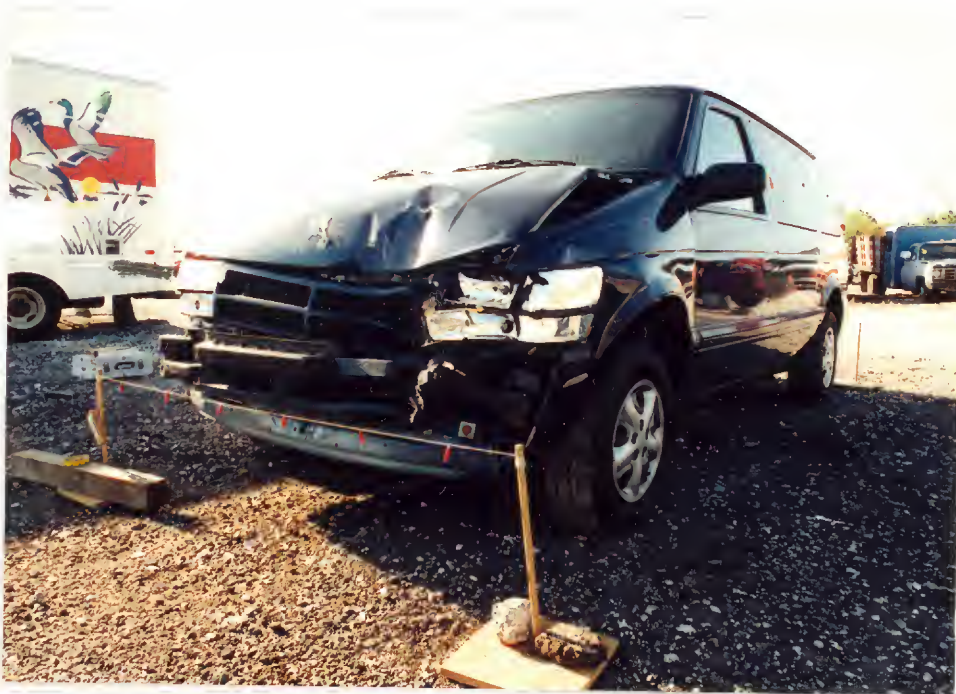
| <u>Air Bag Vehicle</u> | <u>Vehicle #2</u> |
|---|---|
| The 1995 Dodge Caravan sustained moderate damage that was distributed across the entire frontal plane of the vehicle. The front-to-side impact sequence crushed the front bumper structure of the Caravan and separated the bumper fascia from the reinforcement bar. Direct contact damage, which consisted of abrasions, began at the right front corner of the bumper fascia, 77.5 cm (30.5") right of center, and extended 154.31 cm (60.75") to the left corner area. The vertical height of the direct contact damage extended onto the hood face and leading edges of the front fenders. | The 1992 Chevrolet Lumina APV sustained moderate left side damage from its impact sequence with the Dodge Caravan. The composite exterior body panels of the Lumina APV compressed as a result of the impact and rebounded to approximately the original positions. The steel substructure of the left B-pillar and sill areas retained the crush pattern from the engagement. Direct contact damage consisted of abrasions and paint transfers which began 116.2 cm (45.75") forward of the left rear axle position and extended 160.0 cm (63.0") forward to the left front wheel. |

14. Left front three-quarter view.

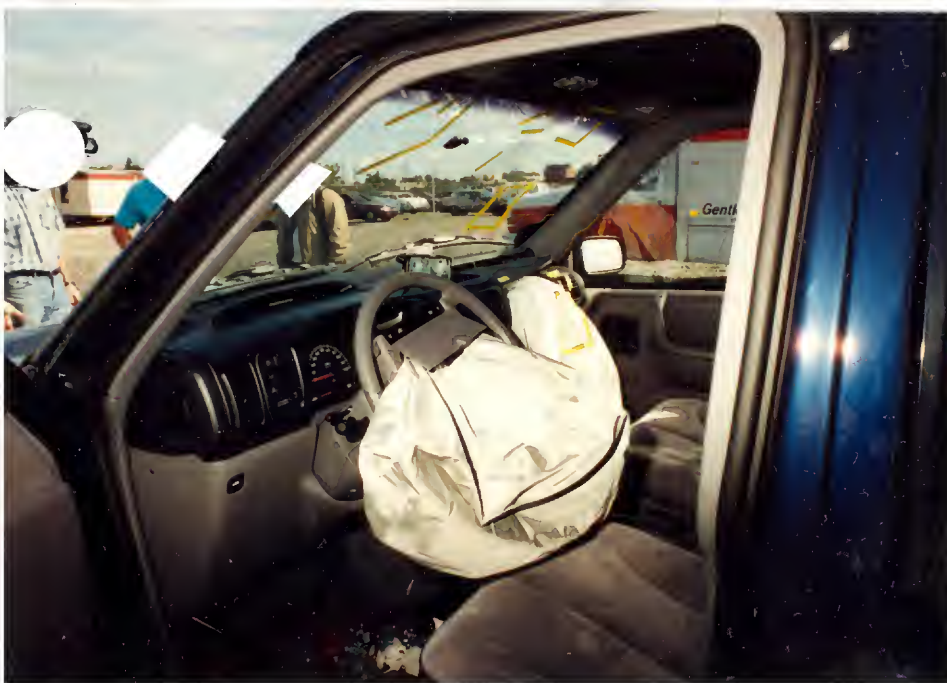
The driver side air bag deployed as designed from the H-configuration cover flaps of steering wheel mounted module assembly. There was no damage directly associated with

23. Overall view of the driver's compartment and deployed air bags.

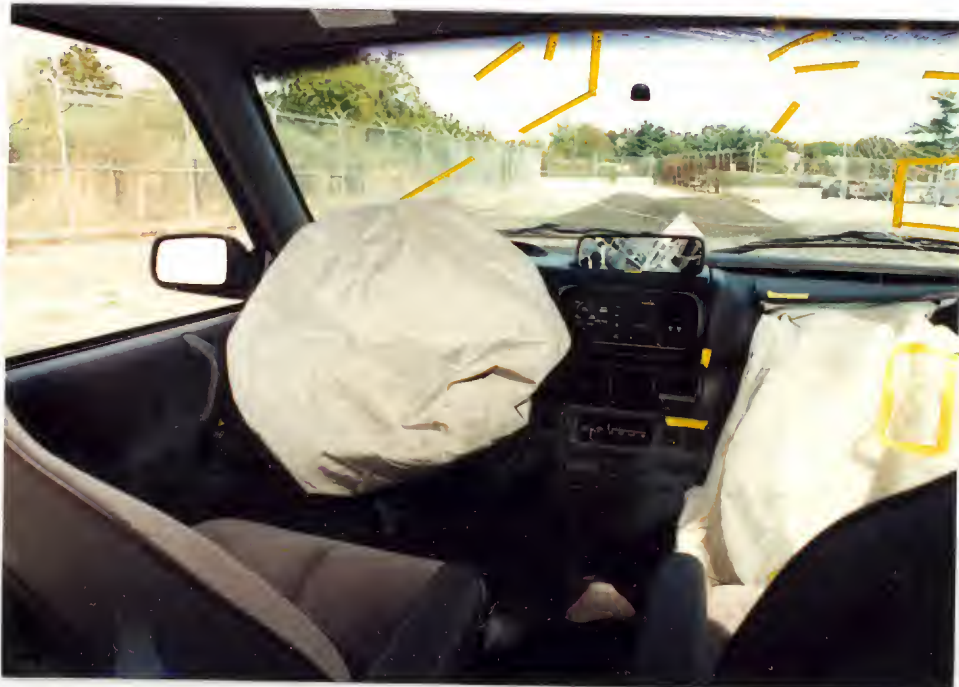
There was evidence of driver loading on the air bag, however, a series of horizontal blackish transfers were noted to the face of the bag, on the right side. These transfers probably occurred as the bag expanded against the gas generator mounting bracket during deployment. There was no restriction of the bag during deployment by an out of position occupant.

28. Overall view of the driver's side air bag from the rear seat area.

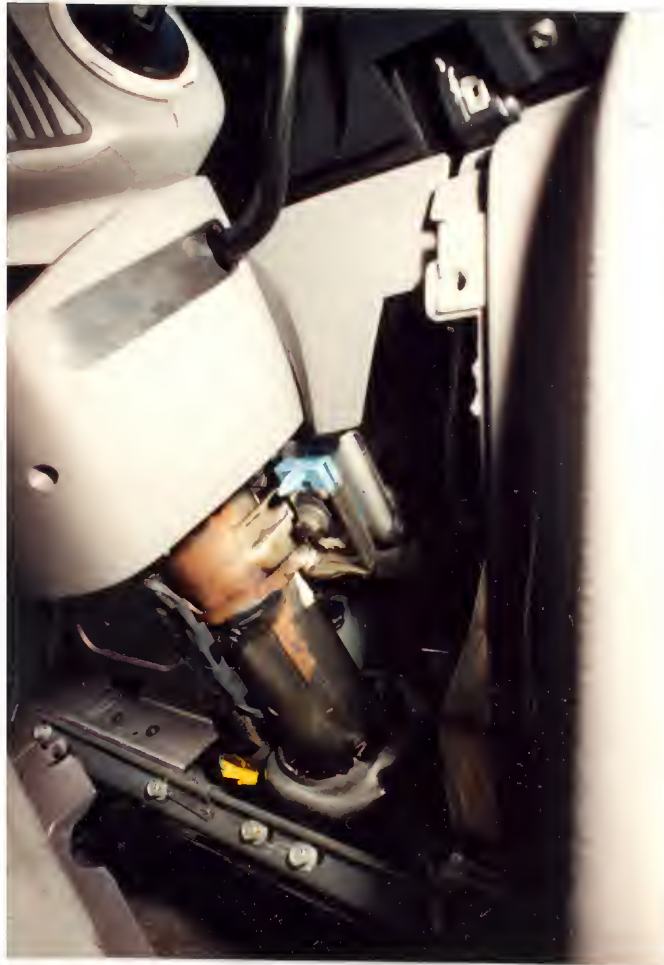
32. Right shear capsule; elongated block, no compression.

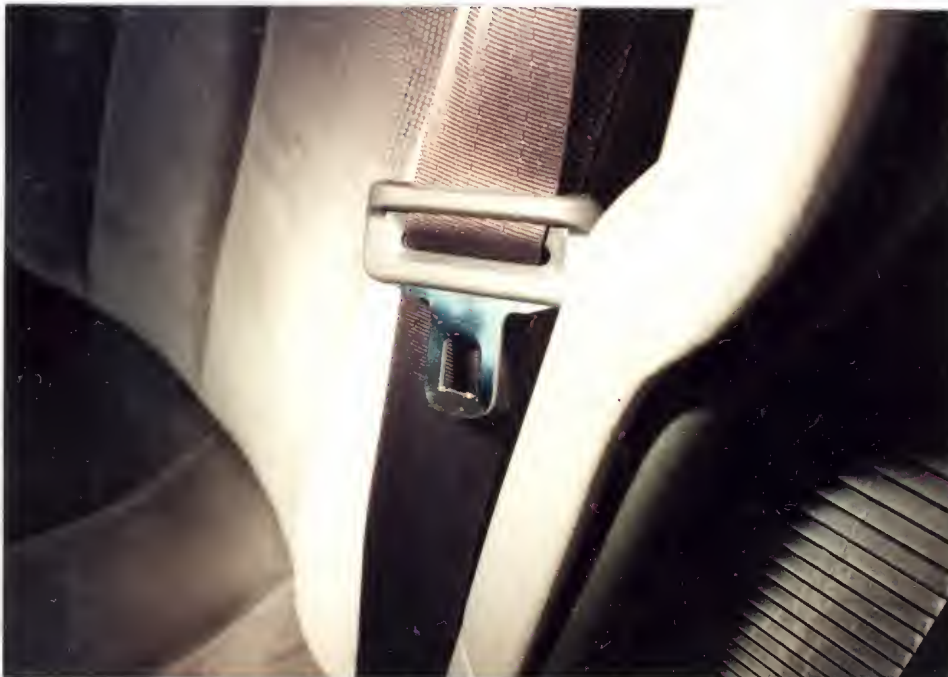
34. Driver's side latchplate; minimal routine usage wear marks.

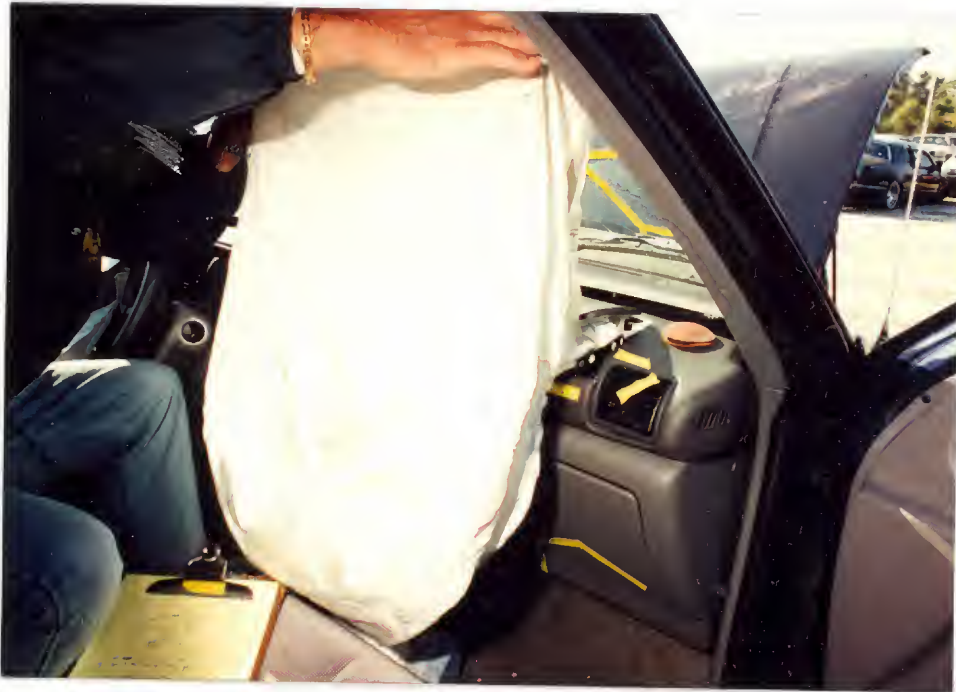
As the SRS deployed, the forward position of the right front child occupant altered the normal deployment path of the passenger side air bag. The module cover flap opened in an upward direction at the designated tear points. Air bag fabric transfers were noted to the leading edge of the lower left quadrant of the cover flap. These transfers began 10.8 cm (4.25") left of the center point of the cover flap and extended 2.5 cm (1.0") to the left. There was no damage or evidence of occupant contact to the module cover flap. The trim panel located forward of the passenger side module assembly was partially disengaged along the base of the windshield. Separation of the three retaining clips resulted in vertical displacement of the entire right side of the plastic panel (refer to Photograph No. 41). As the bag expanded from the module assembly, it contacted the underside of the child occupant's chin, face, and the anterior aspect of her neck and chest as she moved on a forward trajectory in response to the pre-crash braking force and subsequent impact force. The result of this occupant interaction allowed the bag to expand between the child occupant and the module assembly.

39. Overall view (expanded) of the passenger side air bag.

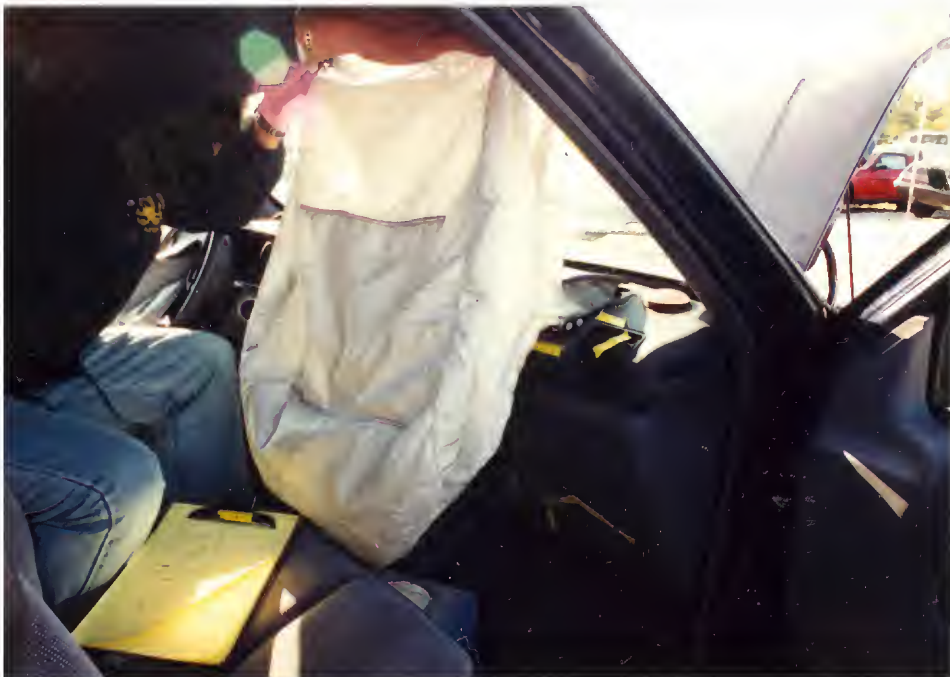
40. Horizontal vinyl transfers on the right side of the passenger side air bag.

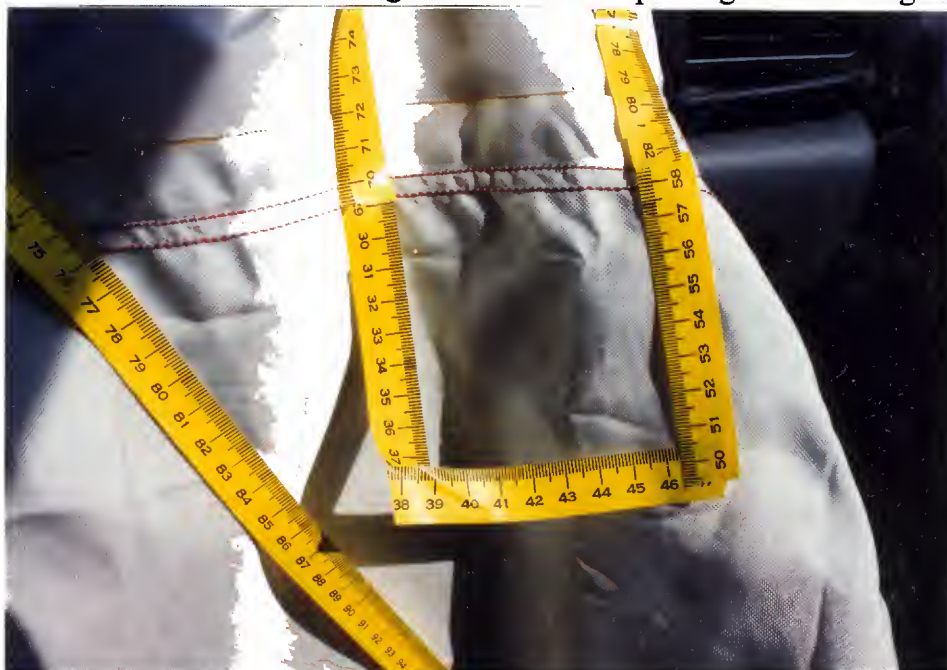
Passenger side air bag deployment against the child occupant's facial and neck areas resulted in numerous areas of tissue transfers. Located at the upper right quadrant of the air bag was an area of scattered tissue fragments which occupied an area of 3.2 x 4.45 cm (1.25 x 1.75"). These transfers are documented in Photograph Nos. 43 and 44. Additional tissue transfers were noted to the upper right side surface of the bag. These areas consisted of heavy transfers embedded into the fabric of the bag. The first tissue transfer to the side of the bag was located 12.7-20.3 cm (5.0-8.0") below a triangular blue stitch line and 7.0-10.8 cm (2.75-4.25") right of the apex of the stitch pattern. The second transfer extended 15.9-21.6 cm (6.25-8.5") right of the blue stitch line apex and continued from the end of the stitch line to a point located 7.6 cm (3.0") below the stitch line (refer to Photograph Nos. 45-48). An additional area of tissue was noted to the lower right quadrant of the windshield. This tissue involved fragments that were expelled from the occupants neck area as the bag expanded against the soft tissue.

44. Close-up view of the above tissue transfer.

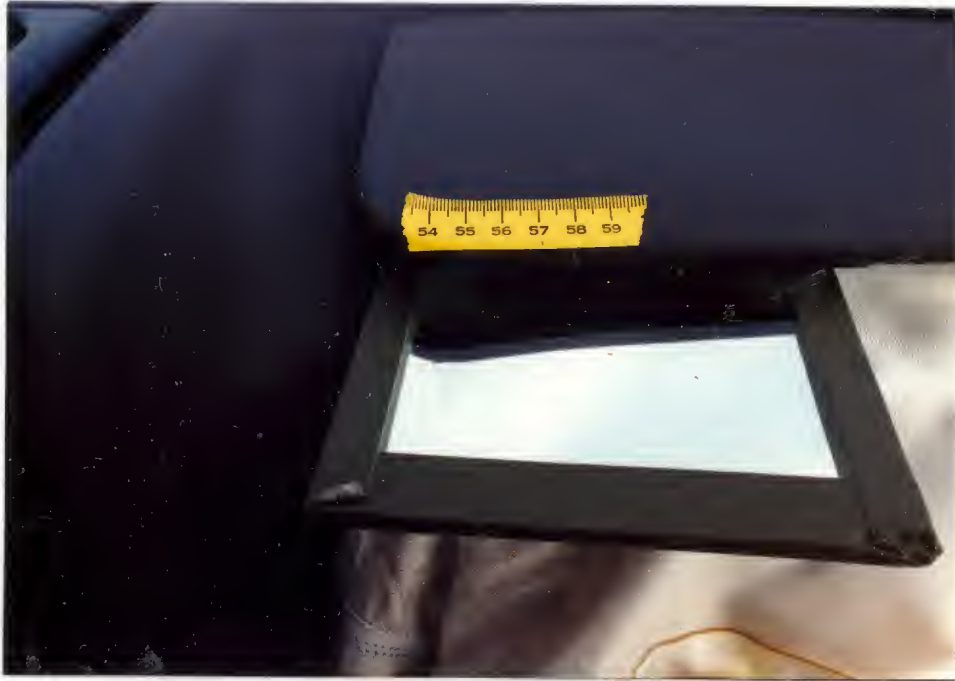
The bag expanded against the stamped steel air bag mounting bracket. The sides of the bracket were bowed outward approximately 3.2 mm (0.125") while the lower flange of the bracket was bowed 2.5 cm (1.0"). The outward bowing of the lower flange deflected the padded mid instrument panel 1.3 cm (0.5") downward at the mid point of the module assembly. An air bag fabric transfer was noted to the deformed padded mid panel (17.5-19.5") left of center and 69.9 cm (27.5") above the floor pan. The bowing of the module assembly, in combination with the opening of the top hinged cover flap and air bag expansion, resulted in a tear of the mid/upper instrument panel juncture at the narrow point adjacent to the right vent louver (refer to Photograph No. 51). A patterned air bag fabric transfer was noted to the left side of the right vent louver. The transfer measured 3.8 cm (1.5") vertically and 4.4 cm (1.75") horizontally across the upper left corner of the vent assembly.

53. Underside view of the left corner of the passenger side air bag module cover flap.

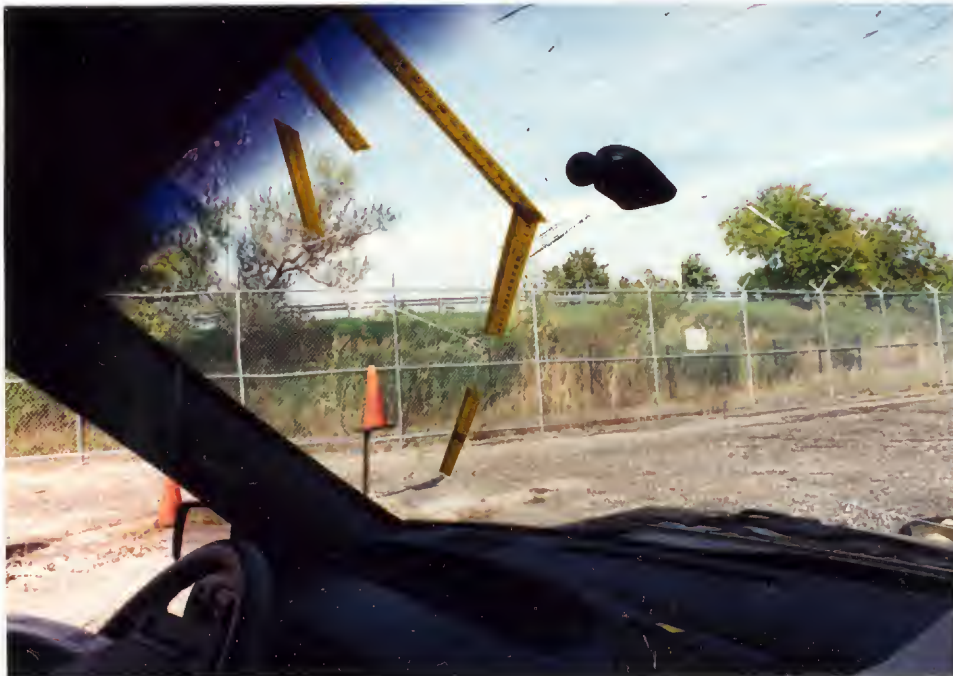
The left side area of the expanding passenger side air bag contacted the interior mounted rear view mirror as the right front occupant altered the deployment trajectory of the bag. The bag contact produced a fabric transfer to the right side of the mirror and displaced the mirror to the left, separating it from the windshield mount. Although no damage occurred to the plastic frame of the mirror, the contact cracked the full width of the mirror glass. The separated mirror was displaced across the left side of the windshield before coming to rest on the upper instrument panel at the base of the left A-pillar.

64. Mirror scuff across the left side of the windshield.

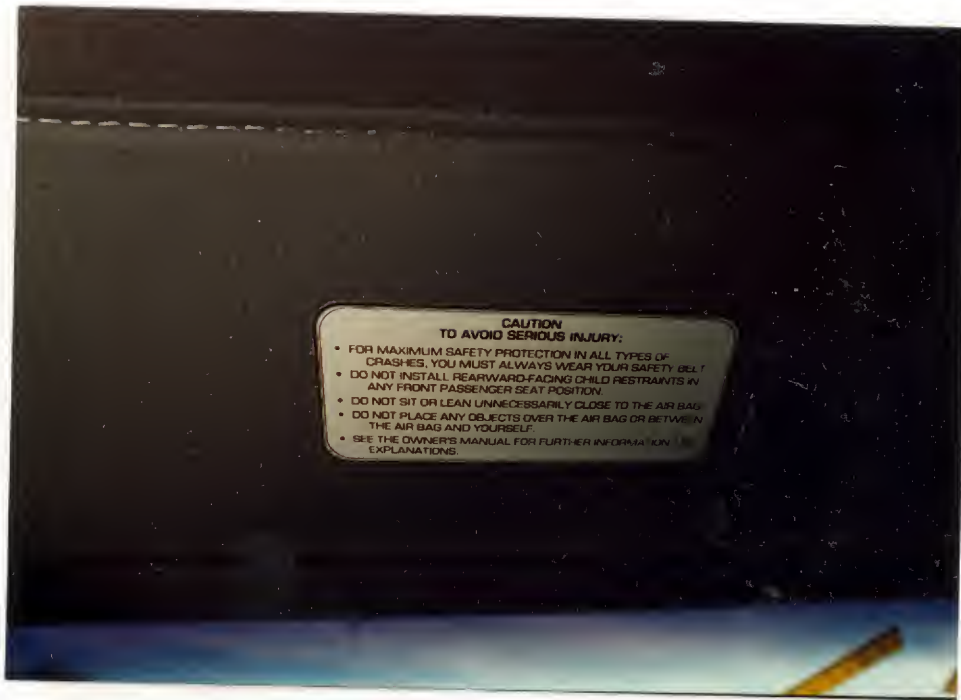
69. Warning label on the right front sunvisor of the Dodge Caravan.

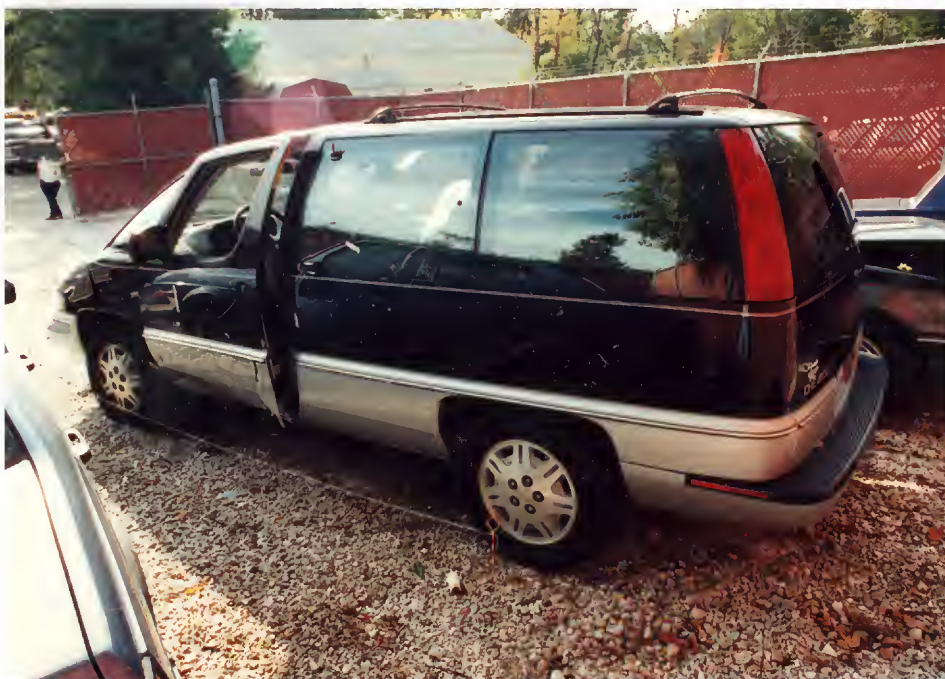
77. Left side view of the Lumina APV.

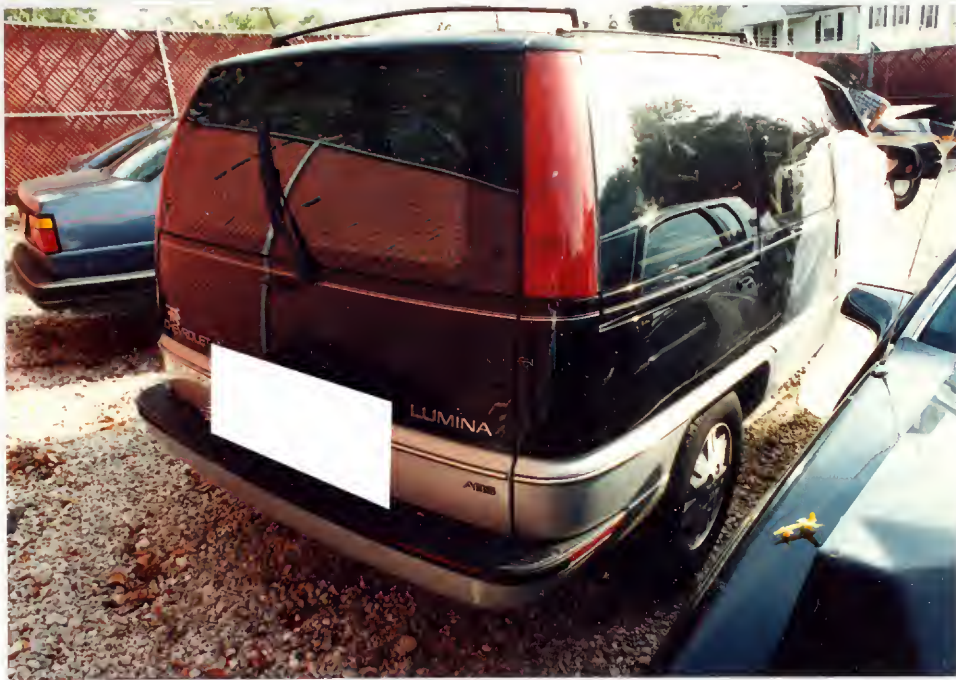
80. Right rear three-quarter view of the Lumina APV.

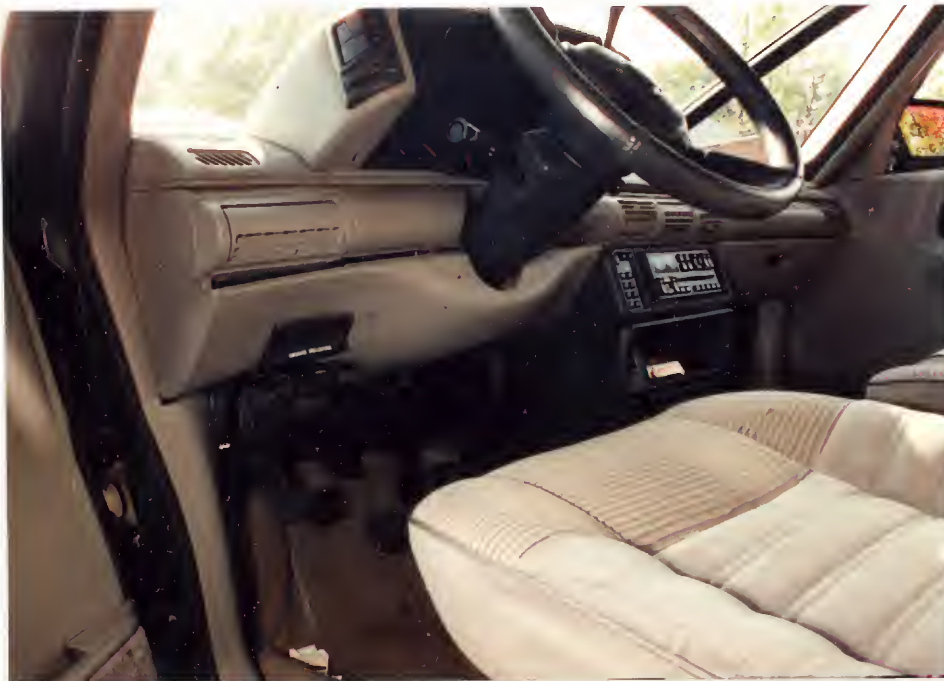
81. Interior view of driver knee contact to the lower instrument panel.
